# SERVICE No. 246 BULLETIN

Piper Aircraft Corporation

Subject: Modification of Oxygen Cylinder Rear Retaining Strap  
Piper Part Number 758 109

Models Affected: PA-30 Twin Comanches (NOTE: Applicable only to  
aircraft that have had an oxygen system installed at  
the factory or aircraft that have had Piper Oxygen  
Installation Kit 757 100 installed.)

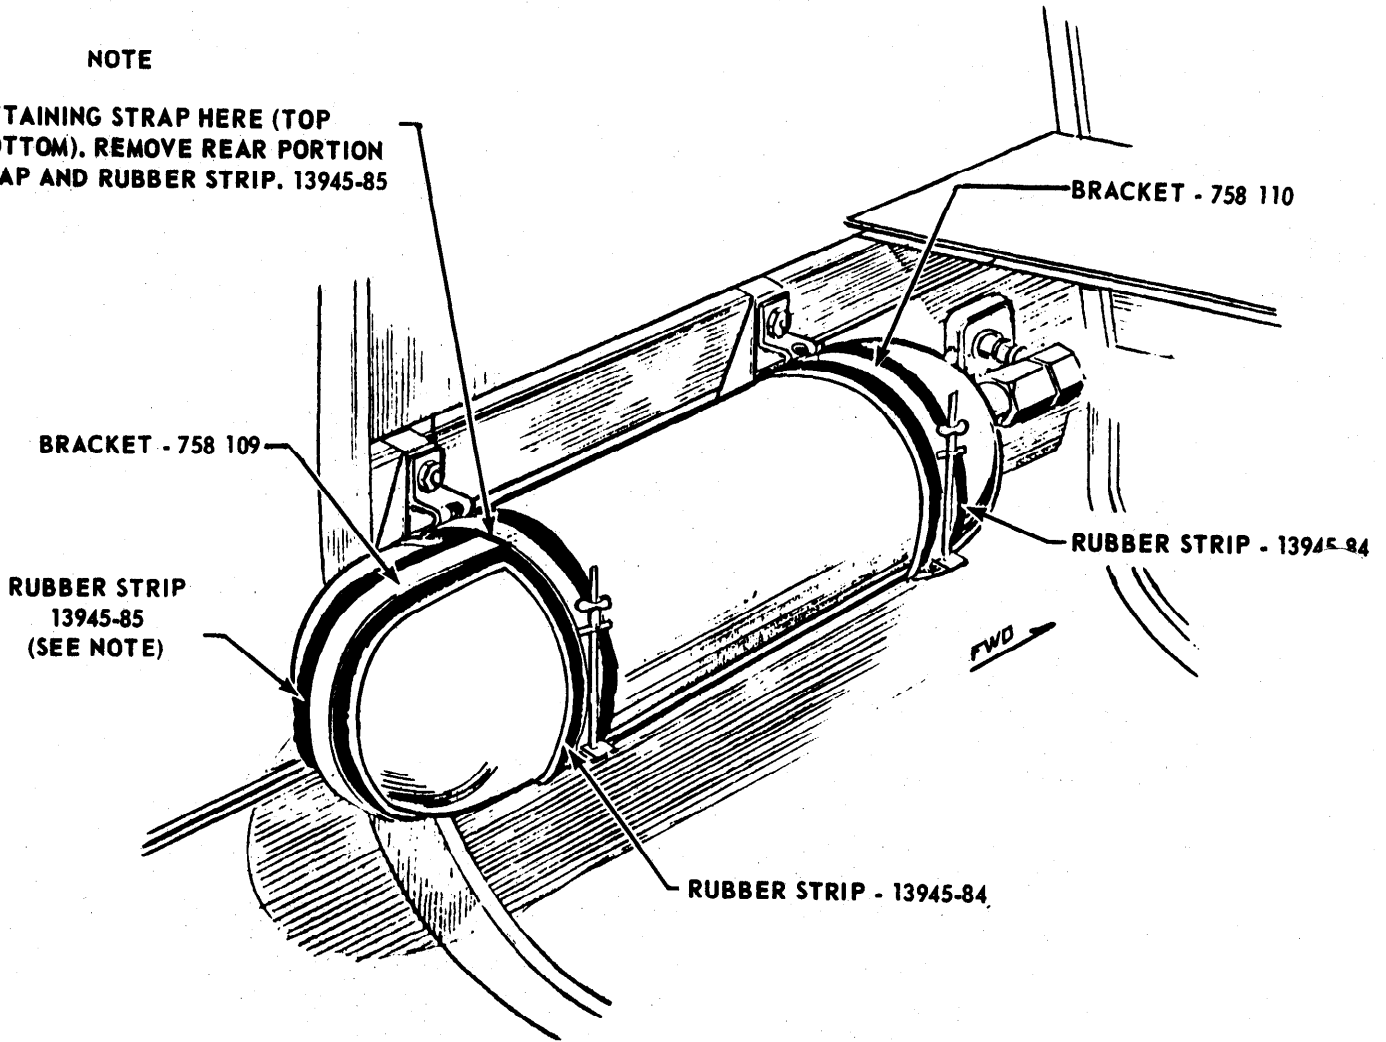
Reason For Bulletin: Modification of the oxygen cylinder rear retaining strap  
part number 758 109 to preclude the possibility of the  
strap rubbing the rudder control cable.

**CUT RETAINING STRAP HERE (TOP AND BOTTOM). REMOVE REAR PORTION OF STRAP AND RUBBER STRIP. 13945-85**
