SERVICE BULLETIN

No. 331

Piper Aircraft Corporation

Subject: Electric Trim Switch Inspection and Modification

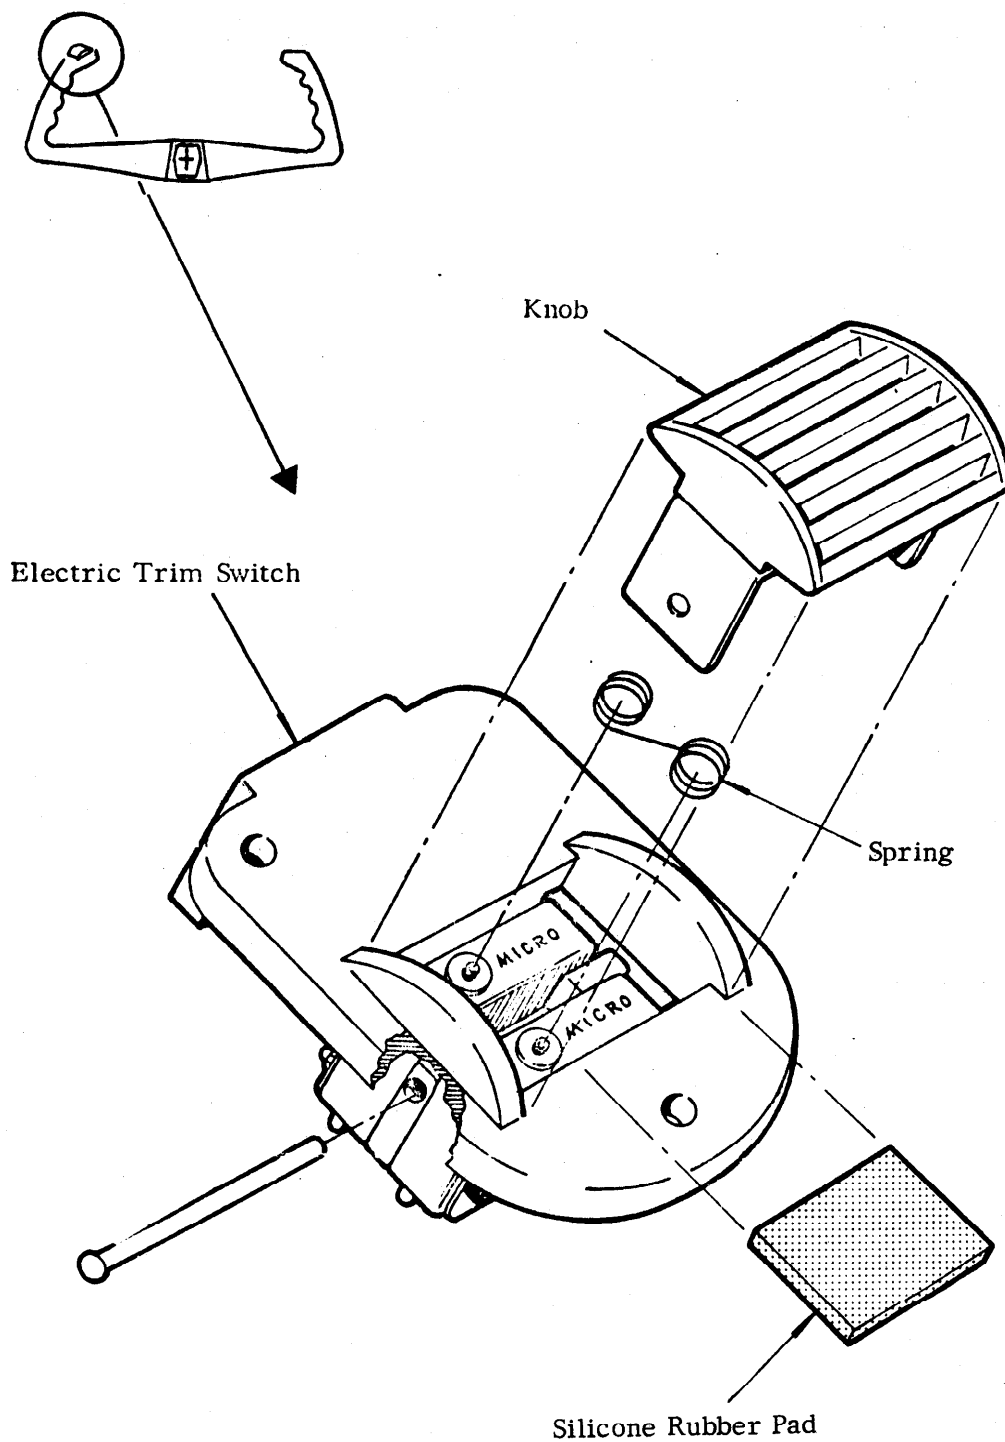
To modify the pilot's control wheel mounted "rocker" type trim switch by replacing the existing neutral return device (silicone rubber pad) with a coil spring (reference sketch on page 4 for a general description).

- I. Prior to each flight, inspect the pilot's control wheel mounted "rocker" type trim switch for proper operation per Instructions No. 1, below;
- II. At the next 100 hour inspection or annual inspection (whichever occurs first), modify the trim switch in accordance with Piper Kit No. 760 505, Electric Trim Switch Modification.
