# SERVICE BULLETIN

411A

Piper Aircraft Corporation

Subject: Stabilator Torque Tube Bearing Block Attachment Fitting Rivet Replacement

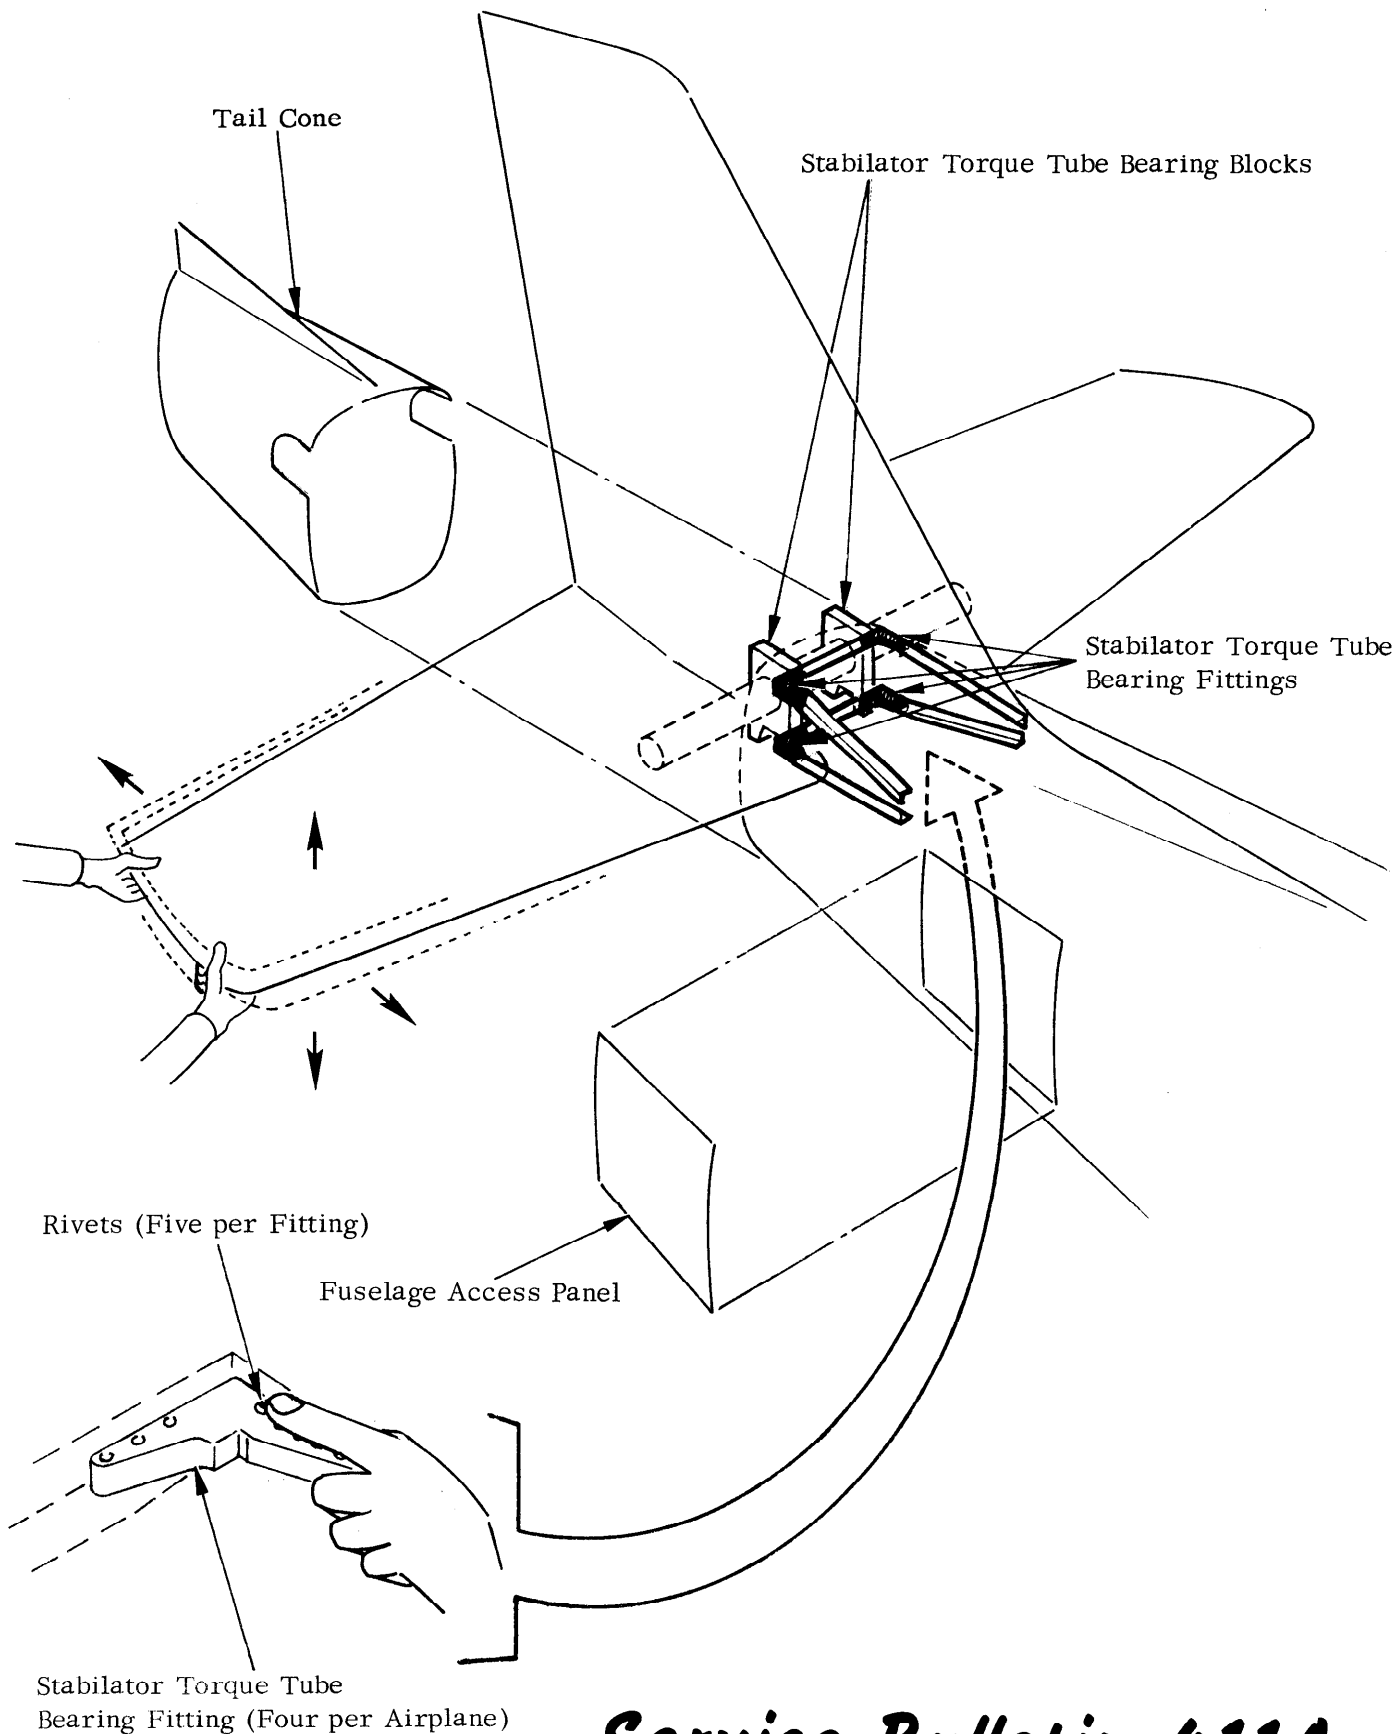
# *Service Bulletin 411A*

Purpose: Information has been received by the factory describing movement and/or noise in the area where the stabilator assembly joins the fuselage. It has been determined that the above described condition may have been caused by one of the following (refer to attached sketch for a pictorial description of the affected areas):

1. Stabilator torque tube bearings not firmly seated in the stabilator torque tube bearing blocks.
2. The holes in the stabilator torque tube bearing upper and lower fittings may be enlarged.

2. Simultaneously (with Step 1, above), have another person check closely for movement and/or noise in the area described in Purpose, above (the attached sketch illustrates a recommended method of detecting movement in the stabilator torque tube bearing fittings area).
3. If there are no indications of movement and/or noise, no further action is required (other than log book entry).
4. If there is movement and/or noise in the area described in Purpose, above, immediately contact the Customer Services Department, Piper Aircraft Corporation, Lock Haven, Pennsylvania 17745.
