SERVICE BULLETIN

No. 464A

Piper Aircraft Corporation

Subject: Inspection of Stabilator Torque Tube Bearing Block Attachment Fitting Rivets.

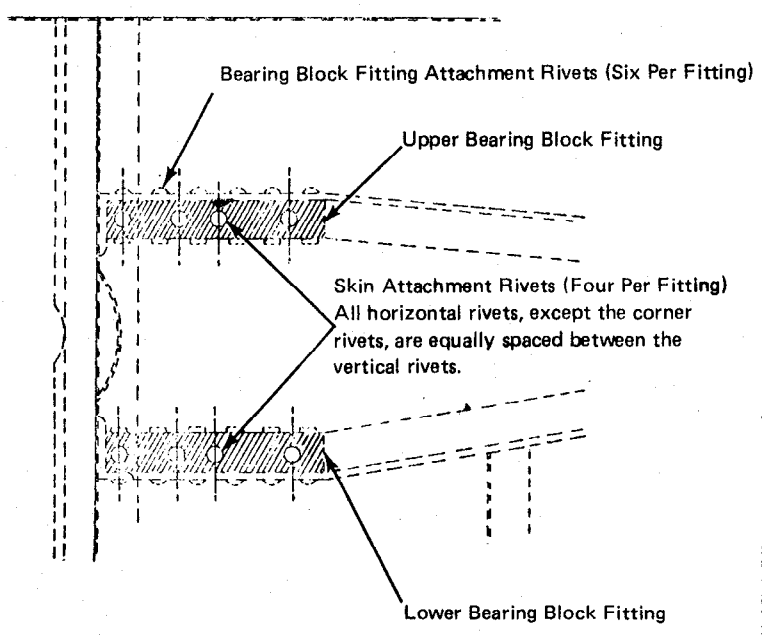
VIEW A-A: CORRECT RIVET ALIGNMENT

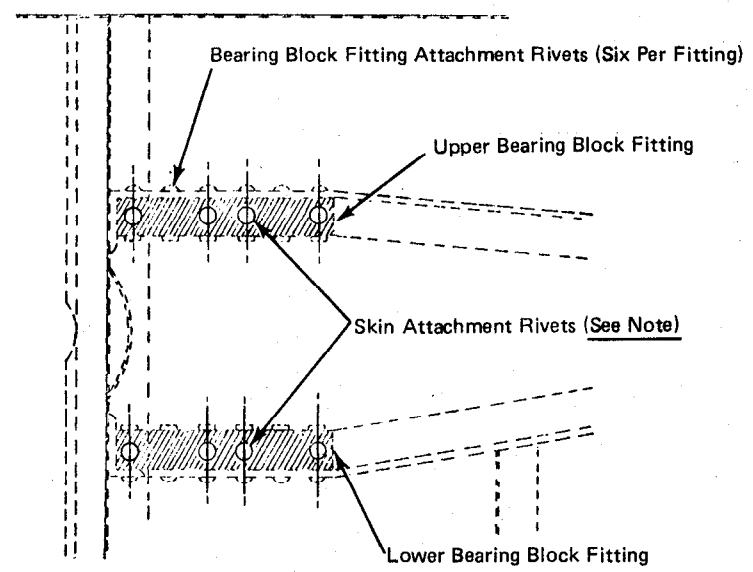
VIEW A-A: RIVET ALIGNMENT which may have resulted in rivet penetration:

NOTE: All horizontal rivets, except the corner rivets, are incorrectly installed in this view as they are aligned with the vertical rivets. If more than two rivet alignments are evident in each fitting, it will be necessary to install Kit 760 835.

1. One (1) each PER FITTING (i.e., each kit contains sufficient material to modify one only Stabilator Torque Tube Bearing Block Fitting), Piper Kit Number 760 835, Hi Shear Rivet Replacement, if required per Instructions number 3, above.
2. Two (2) each per aircraft Cover Plate, Part Number 28216-02, if installation of Kit 760 835 is required per Instructions number 3, above.
