SERVICE BULLETIN

No. 527

Piper Aircraft Corporation

Electric Trim Switch Modification

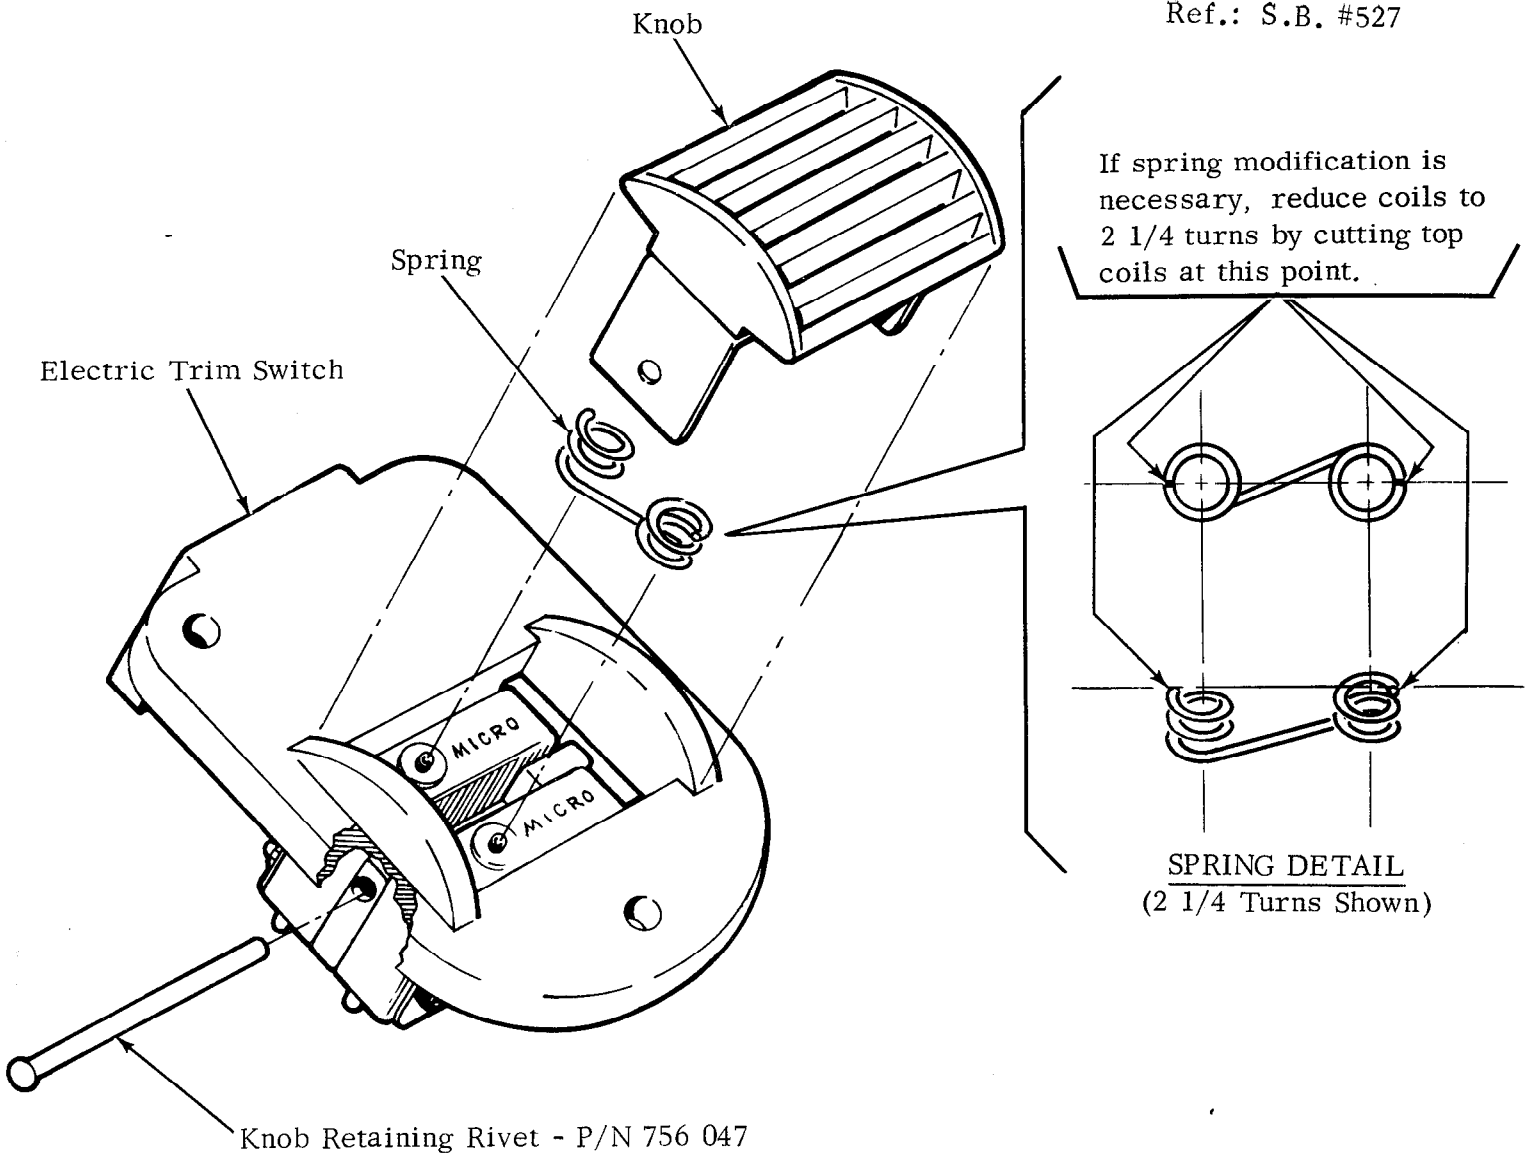
Purpose: Field reports describe a condition wherein the pilot's control wheel mounted "rocker" type electric trim switch tends to "hang up" in the "FWD"/"NOSE UP" or "AFT"/"NOSE DOWN" mode; i.e., fails to return to the "neutral" position following removal of thumb pressure. This condition occurred on some aircraft modified in accordance with Service Bulletin No. 331. Subsequent investigation revealed that the switch return coil springs supplied with Piper Kit No. 760 505 (Electric Trim Switch Modification), per Service Bulletin No. 331 and subsequent production modified models--for a period of time--had an excessive number of coils, which may cause the end of the coil spring to become caught between the switch "rocker" actuator and the micro switch body, thus preventing spring assisted return of the switch to "neutral".

To remedy--and prevent--this condition, this service release provides instructions to modify the electric trim switch return spring by reducing the number of coils (from 2 1/2 turns to 2 1/4 turns--reference attached sketch/instruction sheet for an illustrated view of this condition).

1. Carefully remove placards from electric trim switch.
2. Remove two screws which secure the switch to the control wheel and remove switch.
3. Remove knob retaining rivet by filing peened or crimped head and carefully knocking out.

4. Remove knob and spring from switch.
5. Inspect spring to determine if coils consist of 2 1/4 turns as shown in above detail or 2 1/2 turns.
 - a. If coils consist of 2 1/4 turns, proceed to Step 6.

- b. If coils consist of 2 1/2 turns, modify spring by cutting 1/4 turn from top of coils before proceeding to Step 6. Refer to spring detail above.
6. Place spring (P/N 757 685 - Scott #10004324) over micro-switch buttons with open ends of spring facing up. Spring coils must be concentric with micro-switch buttons and shoulders, and must not rest upon them.

7. Place knob in position and depress slightly so that the new retaining rivet (P/N 756 047 - Scott # 36270) can be installed. Take care not to dislodge spring from position.

8. Test switch action.
9. Crimp or peen end of retaining rivet to retain.
10. Reinstall switch on control wheel with existing screws and cement placards to switch.
