SERVICE *No.884* BULLETIN

Piper Aircraft Corporation
Vero Beach, Florida, U.S.A.

Date April 8, 1988 S/M

Lock Wiring of V-Band Couplings

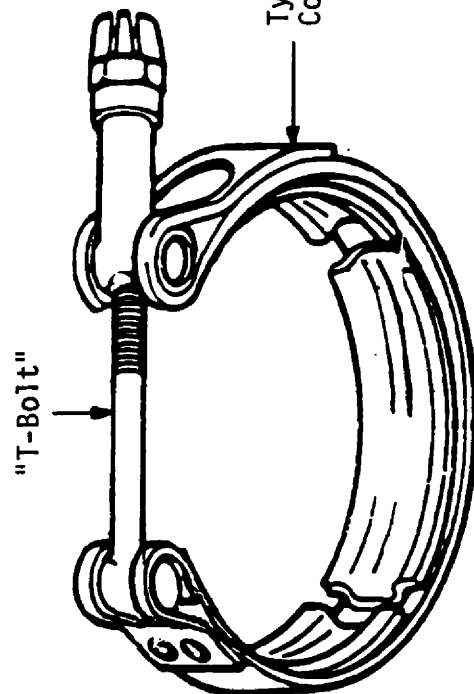
SKETCH "A"

PURPOSE: Reports have been received of broken "T-bolts" in the V-Band Couplings used in the exhaust, bleed air and cabin heat systems on various Piper Airplanes. The failure of a T-bolt can allow the coupling to separate, permitting hot exhaust gases or bleed air to be expelled, creating a fire hazard.

1. Refer to the applicable parts catalog to determine the number and location of V-Band Couplings on the affected aircraft.
2. Inspect all V-Band Couplings for security and integrity of T-bolts and lock wire (if installed). Refer to Sketch "A" attached.
3. If lock wire is damaged or missing, lock wire coupling using MS20995-C41 wire. Refer to Sketch "A".
4. Make an appropriate logbook entry of compliance with this Service Bulletin.
