SERVICE No. 1026 BULLETIN

SUBJECT:

Distribution of Parker Hannifin Airborne Service Letter 48, "Inspection/Replacement of dry air pump flexible couplings".

Service Letter Number: 48

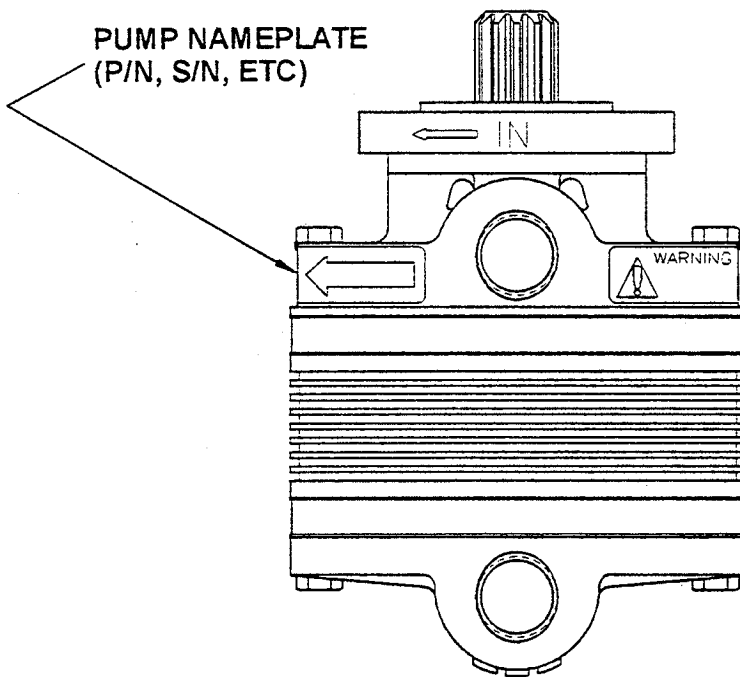
FIGURE 1

Applicability: Airborne dry air pumps, conversion kits and flexible coupling kits with the following part numbers/serial numbers which have not been inspected per this service letter as identified in step number seven of the procedure listed below. These components were shipped from Airborne between 1/1/98 and 10/13/98. Refer to Figure 1 for location of part number/serial number nameplate.
