# SERVICE NO. 1189 BULLETIN

Date: April 29, 2010

**STABILATOR HORN ASSEMBLY INSPECTION**

PA-24 Comanche  
PA-24-250 Comanche  
PA-24-260 Comanche  
PA-24-400 Comanche  
PA-30 Twin Comanche  
PA-39 Twin Comanche C/R

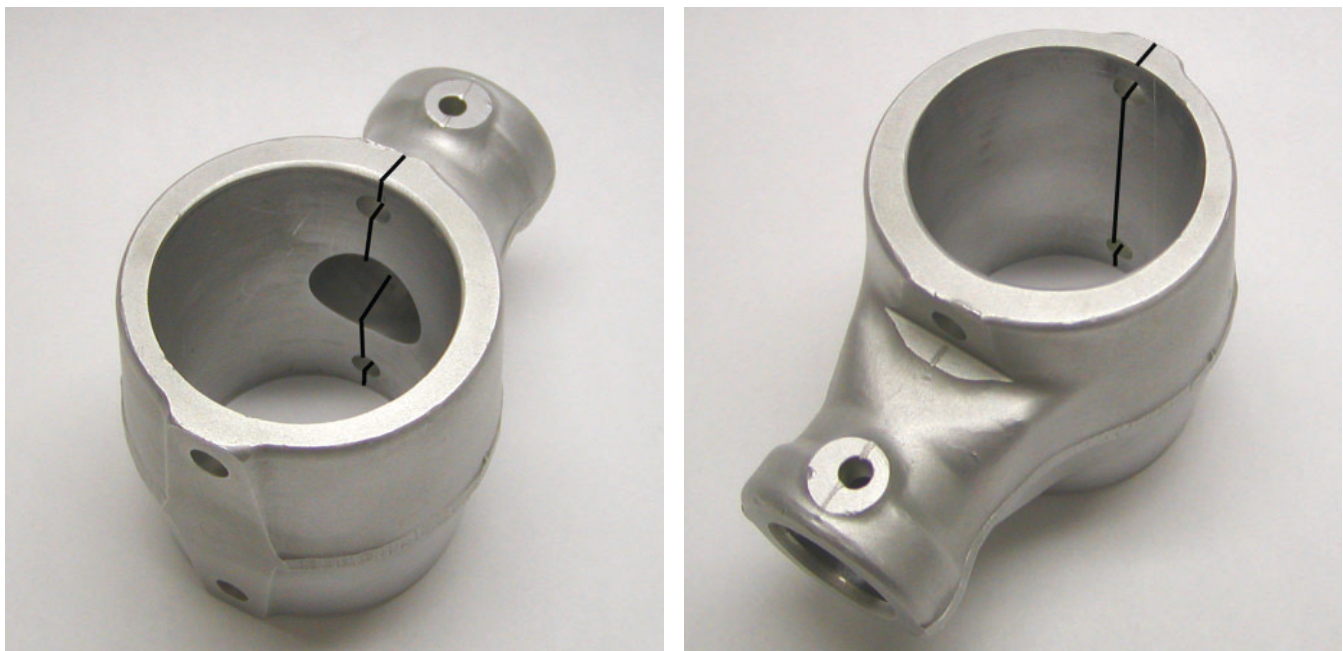
**Figure 1**  
**Lines indicate Inspection Area**

Reports have been received of cracks developing in the Stabilator Horn Assembly. Left uncorrected, this condition could cause separation of the Stabilator Horn from the Stabilator Torque Tube, leading to a reduction in pitch control.

**NOTE:** When cracks occur, they have been found to originate at an inner surface of the Stabilator Horn, as shown in Figure 1. Therefore, removal of exterior paint is not required for inspection. However, the Stabilator Horn **MUST** be removed from the Stabilator Torque Tube, in order to gain visual access to these areas.

4. If cracking or corrosion is discovered in the Balance Weight Tube or Stabilator Horn, order and install a replacement Stabilator Horn Assembly. Refer to Table 1 for the applicable part number.
