SERVICE BULLETIN

No. 232

SUBJECT: Inspection of Brake Disc Assembly

MODELS AFFECTED: PA-30 Twin Comanche, Serial Nos. 30-846 to 30-1105 incl., 30-1107 to 30-1111 incl., 30-1113 to 30-1116 incl., 30-1118 to 30-1129 incl., 30-1132 to 30-1136 incl., 30-1138 to 30-1141 incl., 30-1144

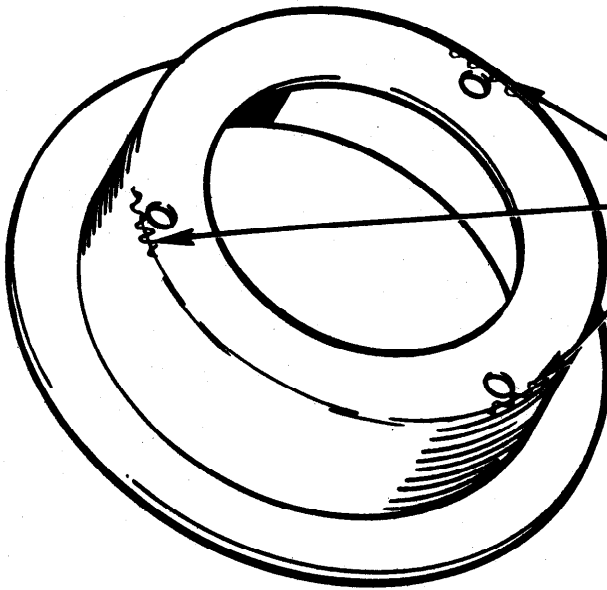
Brake disc assemblies that are not spot faced or are not identified by Cleveland Aircraft Products Part No. 164-22A must have Kit 757 039 installed. (A special washer and an AN5-36A bolt are included in this Kit.)

Inspect for cracks with 10 power glass or equivalent in these areas.

An inspection for cracks must be made of the subject brake disc assembly with a 10 power glass, or equivalent, on each of the main wheels on the aircraft listed above. Inspect disc in the areas shown on the sketch on the reverse side of this bulletin. If cracks are found the brake disc assembly must be replaced prior to the next flight. If a new disc is installed Kit 757 039 must be utilized unless the replacement disc is spot faced or identified by Cleveland Aircraft Products Co. part number as indicated in note above.

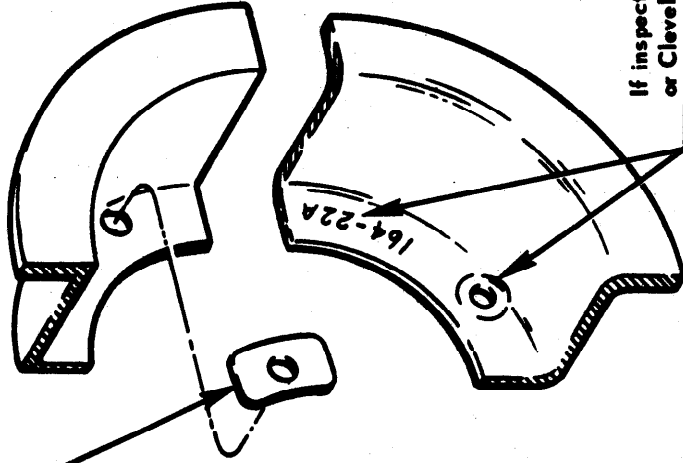
If inspection reveals .562 spot face, or Cleveland Aircraft Products Part No. 164-22A, no further action is required.

Brake disc assemblies with a .562 diameter spot face around the bolt hole and brake disc assemblies that are identified by Cleveland Aircraft Products Co. part number 164-22A stamped on the inside of the disc are not affected by this release and no further action is required. See sketch on reverse side of this bulletin.
